## *Chena River Lakes Project revegetation study*

*Three-year summary*

# CRREL Report 81-18

L.A. Johnson, S.D. Rindge, D.A. Gaskin

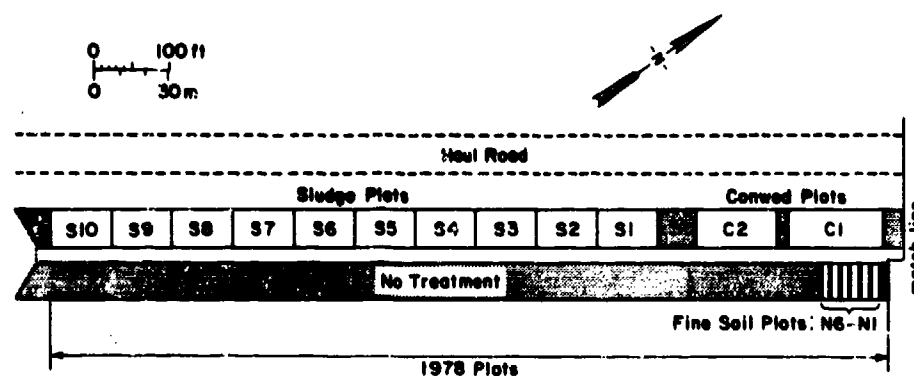
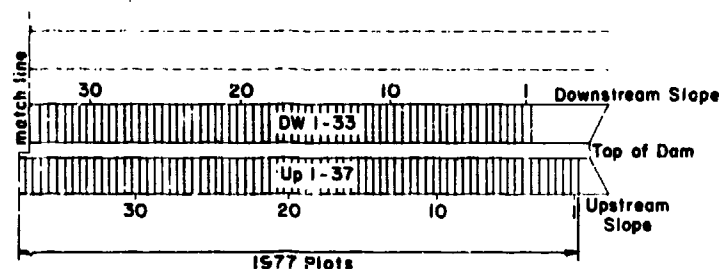
a. End view.

b. Side view.

Figure 3. Plan of the Moose Creek Dam site.

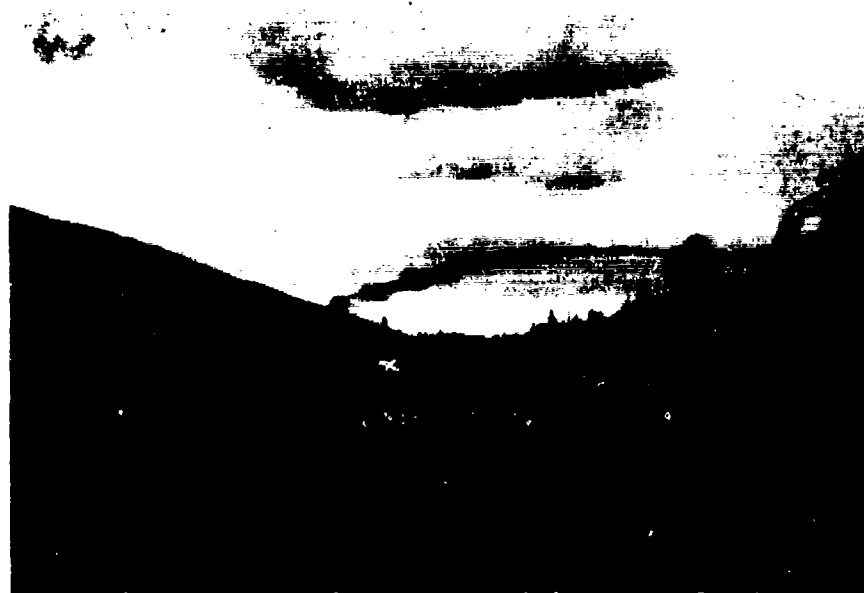
Figure 4. Hydromulching procedure.

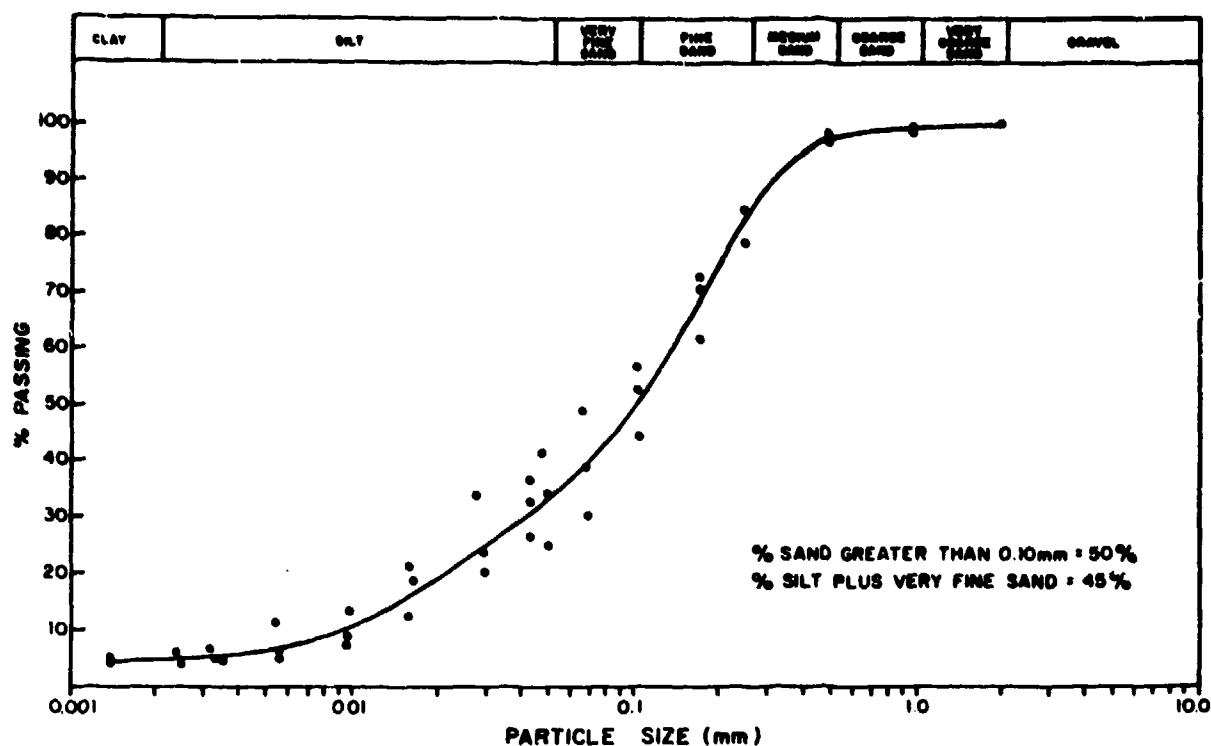
Figure 5. Fine-grained soil size analysis (after Aldrich and Johnson 1979).

were on the downstream side (Table 1). The Alaska District provided the soil from stockpiles originally obtained from the area cleared for the dam. Aldrich and Johnson (1979), who studied the sediment loss on these plots, found that the soil consisted primarily of silt and fine sand (Fig. 5). The soil also had a low organic content ranging from 30 to 40 metric tons/ha.

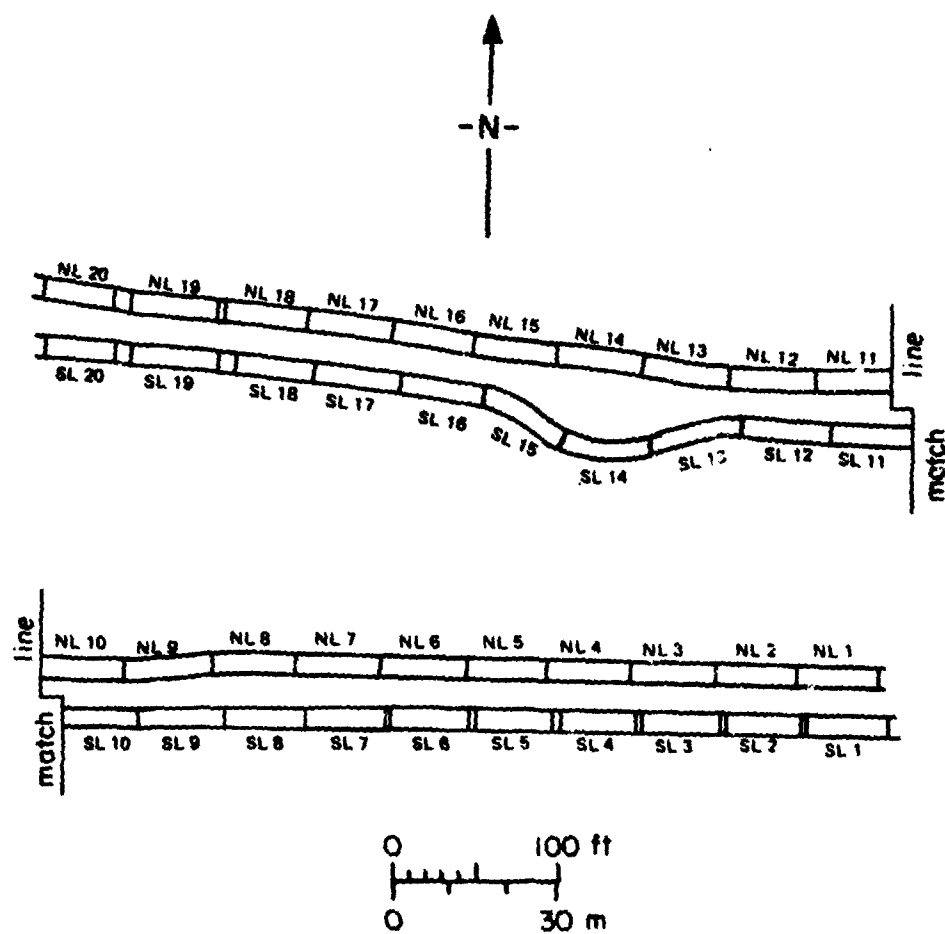
Figure 7. Plan of the Tanana River Levee revegetation site.

The Tanana River Levee site was established in June 1978 and included 20 identical plots (15 × 3 m) on both the north and south sides of the levee (Fig. 2, 7, Table 4). All were treated with S1 seed mix (41 kg/ha) and 10-20-10 fertilizer (880 kg/ha).

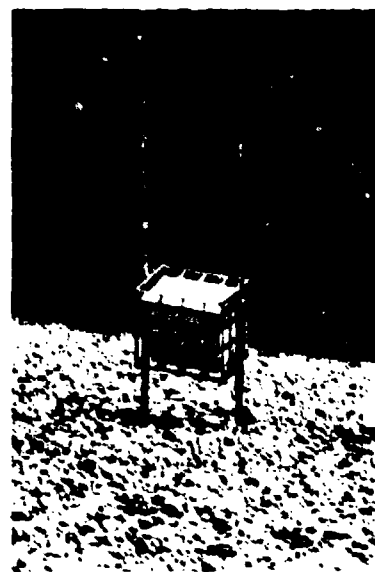
In 1979 three temperature recorders operated from June to September at a location about 50 m north of our main study site on Moose Creek Dam. The instrument and shelter were placed in a locked metal cage to discourage vandalism (Fig. 9). Two recorders were spaced one-third and two-thirds of the way up from the bottom of the downstream (northwest-facing) slope. The other was located one-third of the way up from the bottom of the upstream (southeast-facing) slope. This set-up was designed to compare temperatures at the top and bottom as well as to compare different aspects. Each recorder had two

Figure 9. Air and soil temperature recording instrument.

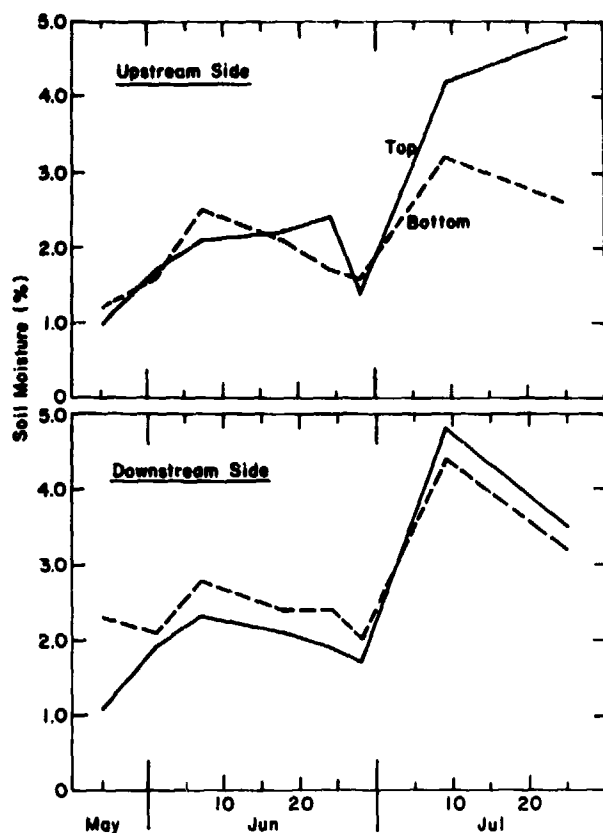
Figure 11 presents the soil moisture data for the upstream and downstream sides of the dam from late May through late July 1979. Each point is an average of three samples.

Soil moisture on the bottom of the downstream side was consistently higher than that on the bottom of the upstream side. The soil moisture from the top showed a similar trend 75% of the time.

The relationship of top- to bottom-slope soil moisture was variable on the upstream side of the dam. However, moisture on the bottom of the downstream side exceeded that of the upper part of the same slope 75% of the time, indicat-

ing downslope movement of water. This relationship was probably obscured on the upstream side of the dam by the lower total soil moisture.

Figure 11. Percent soil moisture at Chena Dam—summer 1979.

These results are confirmed with statistical analyses. When the moisture data were compared using Wilcoxon's signed rank test, the soil moisture of the samples from the bottom of the downstream side was significantly greater at the 0.01 level than the moisture at the bottom of the upstream side. All other comparisons were not significant.

and less so for double fertilization), it is likely that soil moisture limited vegetation growth. Since the upstream side generally had less soil moisture (Fig. 11) and, at least for brome, showed greater moisture stress than the downstream side, it is reasonable that measurements (of biomass, cover and height) should show more growth on the downstream side in the triple-fertilization treatments. However, in both twice-and once-fertilized treatments, the difference between upstream and downstream plots was less dramatic because nutrients, rather than moisture, may have limited growth in at least some cases.

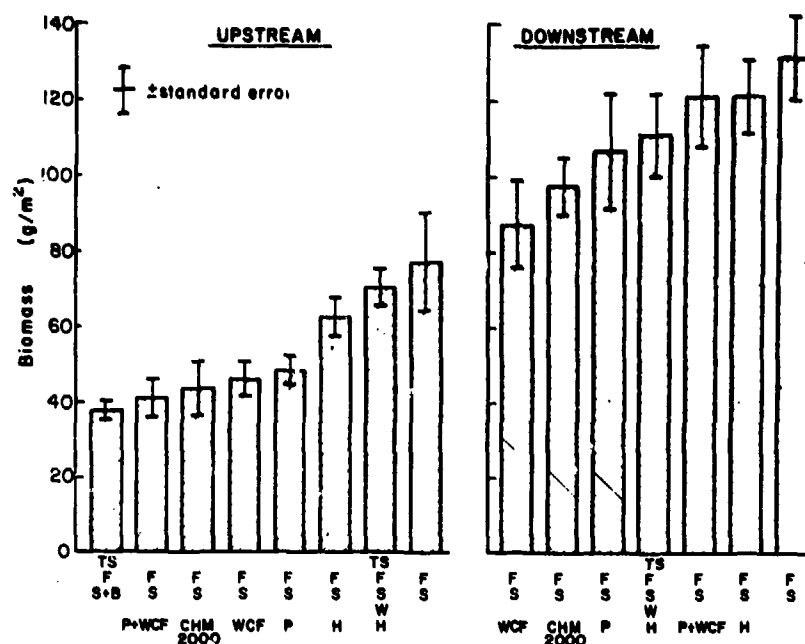
Figure 12. Average dry weight (biomass) of vegetative cover for the 1977 dam treatments in late August 1977.

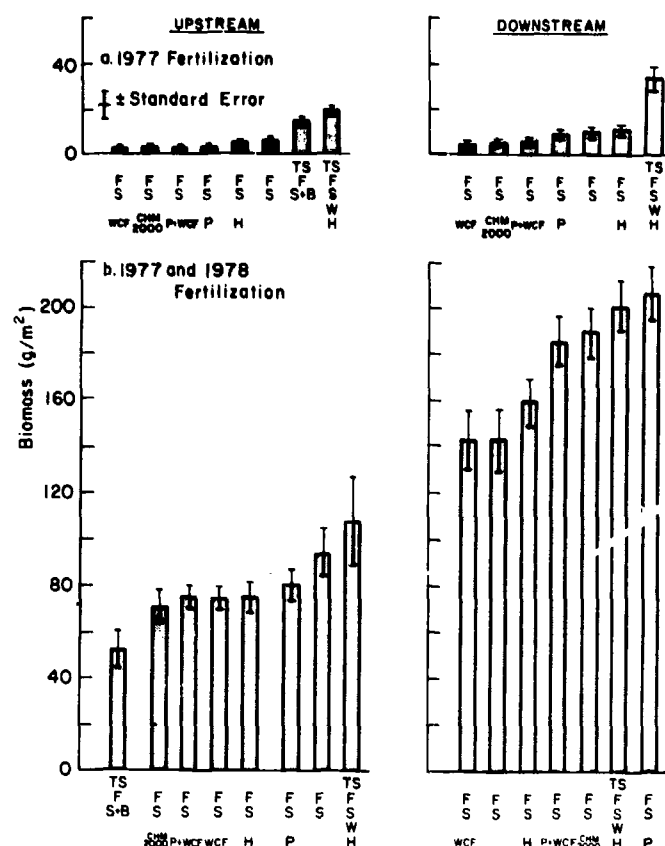
Figure 13. Average dry weight (biomass) of vegetative cover for the 1977 dam treatments taken in late August 1978.

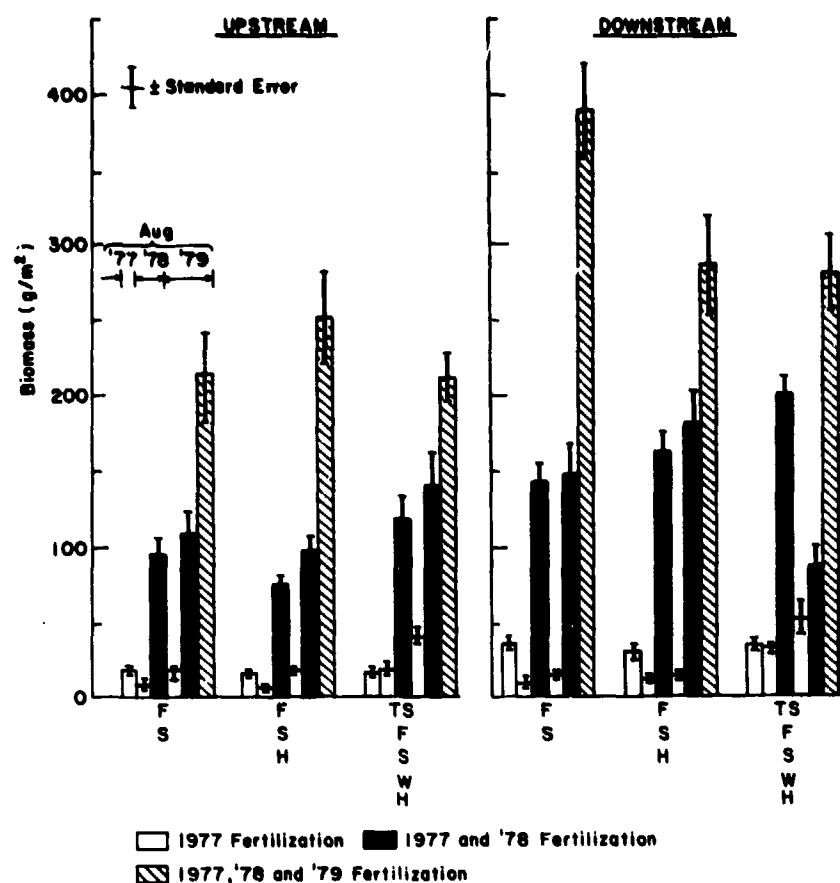
Several multiyear trends are evident in Figure 15. Treatments receiving a single fertilization generally had highest biomasses in 1977, with minimum biomasses in 1978 and intermediate ones in 1979 (compare Fig. 20 to left of Fig. 21). This was probably due to two factors. First, the annual ryegrass produced over 95% of the biomass in 1977 but only 31% in 1978 and 3% in 1979. Therefore, some of the decrease in biomass was due to the low rate of reseeding of annual ryegrass. Second, the ryegrass probably inhibited growth of the perennials in both 1977 and 1978, primarily by nutrient competition (Johnson 1978). Weather may also have had some influence; both 1978 and 1979 had below-average precipitation (Table 5) and were slightly cooler than 1977.

Figure 15. Comparison of biomass means for selected major treatments over three years (1977-1979).

Treatments receiving a second fertilization in 1978 generally produced increased yields in 1978 and had their highest yields in 1979, the second year after fertilization (Fig. 15, right side of Fig. 16, right side of Fig. 19). This was due to the higher soil-nutrient levels of refertilized treatments

The aspect of the plots affected the vegetation responses. As previously mentioned, the downstream plots generally outproduced the upstream plots (Fig. 15). In 1977 and especially 1978 the biomass cover and maximum height of the downstream treatments generally exceeded those of the comparable upstream treatments (68% of the time in 1978) (Fig. 17 and 18; Tables A5-A12). Although in 1979 this was true for only 65% of the comparisons, it was true 90% of the time for the triple fertilization treatments and less often for the double and single fertilization treatments.

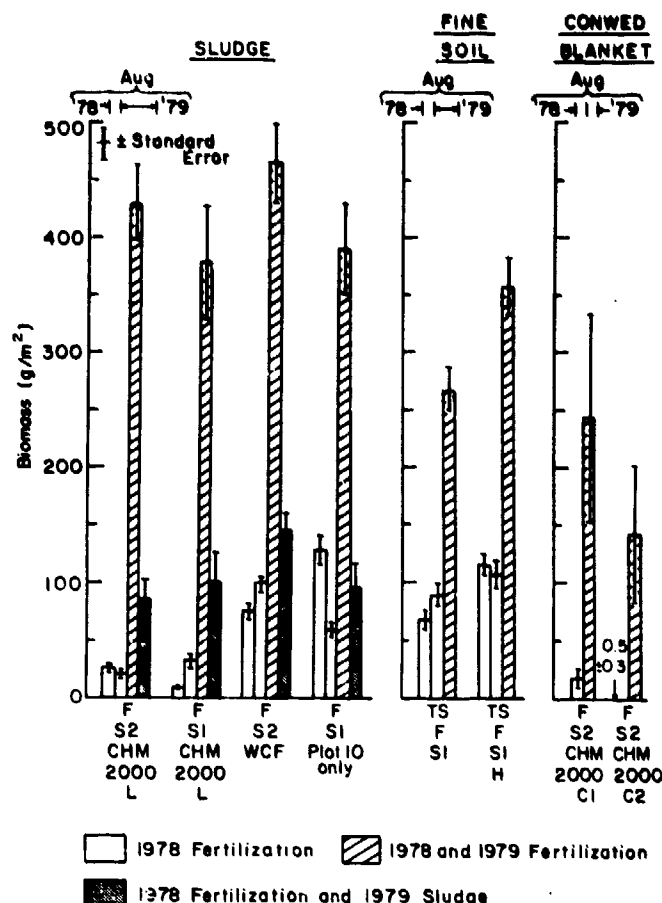
Figure 22. Average dry weight (biomass) of vegetative cover for the 1978 dam treatments in late August 1978 and 1979.

the 1978 and 1979 sludge treatments with additional lime, compared to sludge treatments receiving only fertilizer and mulch (Fig. 22, Tables D1 and D2). The high pH may have directly inhibited plant growth or indirectly affected nutrient availability.

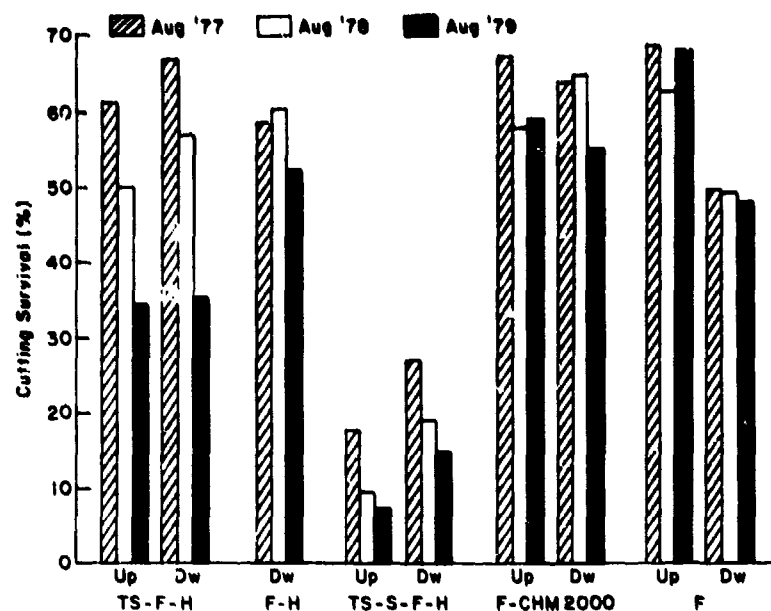
Figure 23. Survival rate of willow cuttings in late August 1977-1979.

Soil moisture was probably a critical factor in determining willow survival. Willows had a higher survival rate on the bottom of the slope, as opposed to the top. Survival at the bottom averaged 12.6% greater in 1977, 9.9% greater in 1978, and 14.8% greater in 1979. Presumably these differences were due to increased soil moisture near the base of the slope, although the soil moisture data are too limited to be conclusive (Fig. 11). Neither refertilization nor aspect had a consistent effect upon survival.

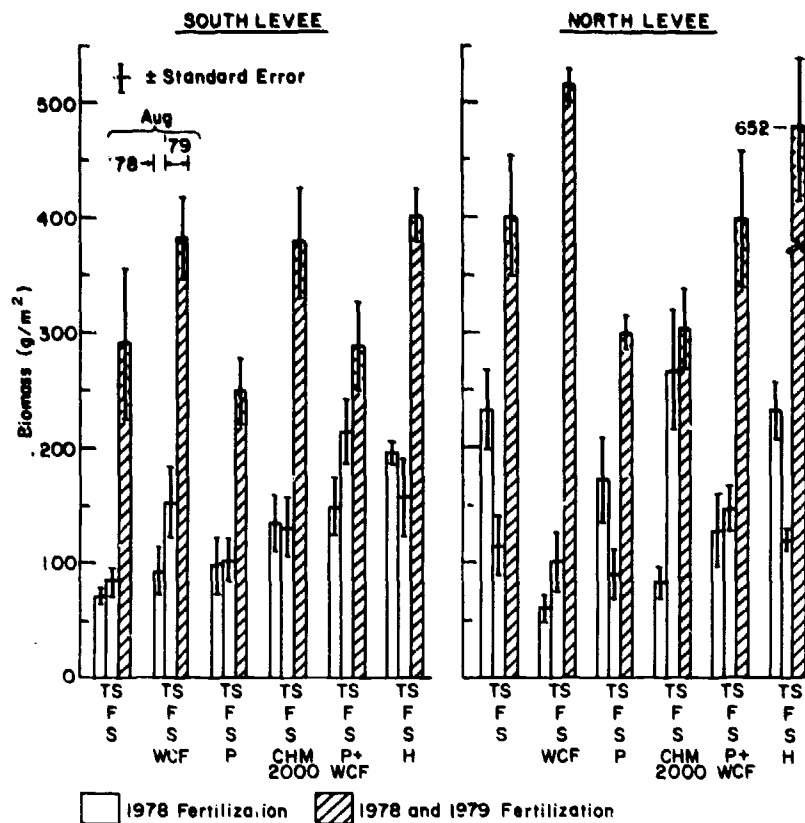
Figure 24 presents the average biomass values for the levee treatments in 1978 and 1979. Tables F1 and F2 list all biomass, cover and maximum

Figure 24. Average dry weight (biomass) of vegetative cover for the Tanana River Levee treatments in late August 1978 and 1979.

heights for the levee treatments in 1978 and 1979, respectively. Aboveground biomass values varied between 60 and 652 g/m<sup>2</sup> in 1978 and 1979. Vegetative cover ranged from 32 to 70%, while maximum heights varied between 36 and 123 cm. Again, maximum heights on the levee exceeded those of the 1977 dam treatments because both brome and meadow foxtail were added to the seed mix.
